SPI Energy Audit / Mold detection cameras

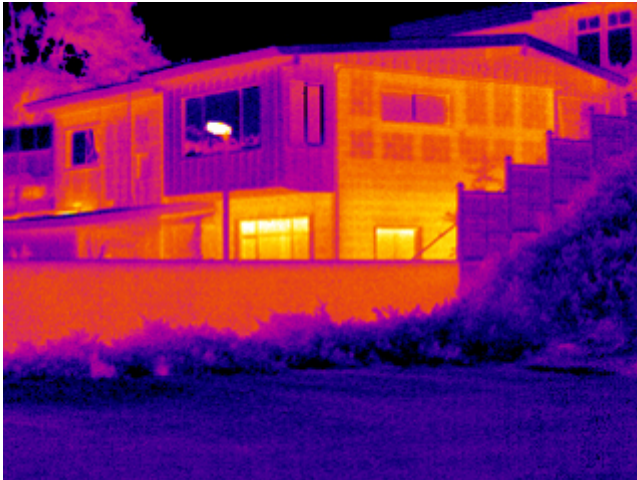
This image shows a wider area of moisture infection but not as high a degree of water saturation. The small degree of temperature differential (around 3 degrees F) indicates this situation.inspection.
